STONE LAKE DAM

(NDI.D. PA-0055,
DER ID. 058-129), Susquehanna

River Basin, Stonestreet Creek, Susquehanna County,
Pennsylvania. PHASE I INSPECTION REPORT,

NATIONAL DAM INSPECTION PROGRAM

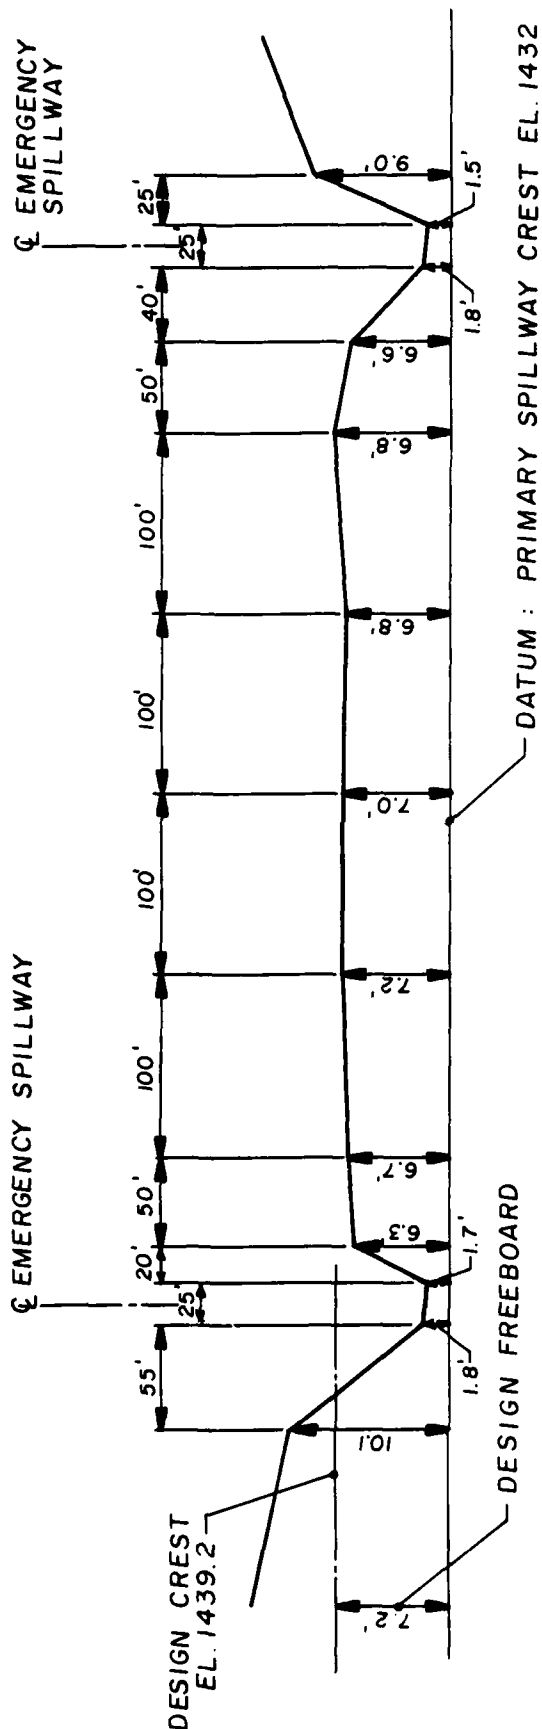
DAM CREST PROFILE (LOOKING DOWNSTREAM)

The dam crest was surveyed relative to the primary spillway crest elevation and was found to have some vertical irregularities. Although the design freeboard for the dam is 7.2 feet, the field survey indicated freeboards ranging from 6.3 feet to 7.2 feet. The lowest area occurred in a section adjacent to the left emergency spillway. The dam crest profile, according to field measurements, is illustrated in Plate 5.
